Indian Steel Sheet Building Group: Technical Note 6.3

Using Metallic-Coated Steel Sheet

Rev 0 May 2013

Successfully Designing Products made with Galvanized Steel Sheet

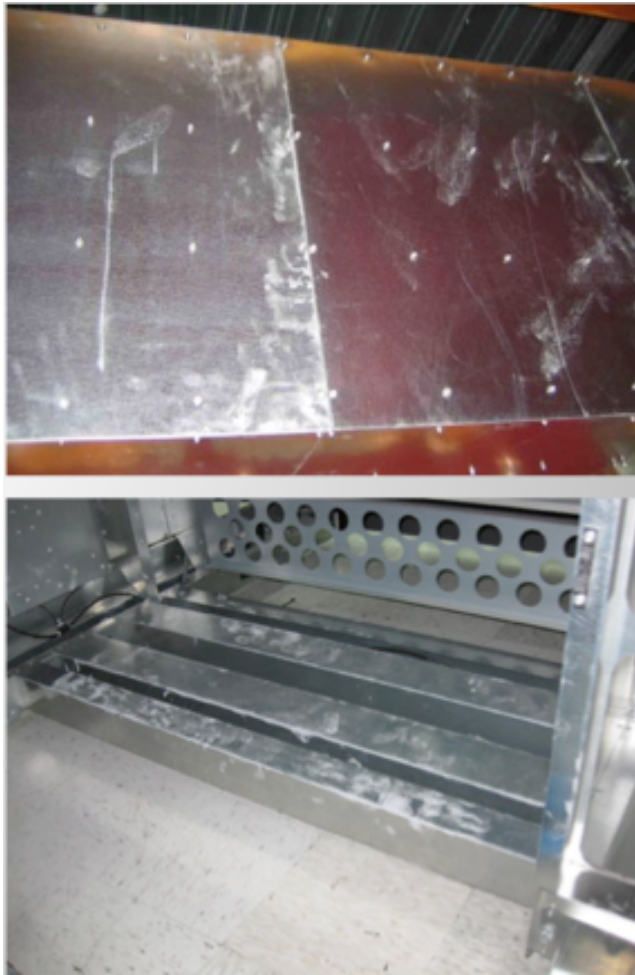
Metallic-coated sheet products are susceptible to surface marking during processing and handling. Galvanized sheet can be permanently affected by white staining due to the perspiration of workers who come in contact with it during the manufacture of products like heating and ventilating ductwork (top left photo). The same problem can happen during manufacture of metal electronic cabinets (bottom left photo). While not harming product durability, the white stains affect its esthetics when intended for an exposed end use. These stains are the result of salt and other compounds in the worker's perspiration reacting with the zinc to permanently mark the surface. Once stained in this manner it is very difficult to remove, and there is no known method of restoring the original metallic lustre. Typical mill passivation treatments do not necessarily offer resistance to this staining.

To avoid fingerprinting and handling marks, the purchaser can request the galvanized sheet be acrylic treated at the time of production. Most producing mills offer this option at an extra cost. For material that is not acrylic treated, and where the final product must be free of these marks, the best option is to have the workers wear long sleeves and clean, soft cotton gloves when handling the sheets during manufacturing and installation. For more information on this problem, refer to *GalvInfoNote 2.13*.

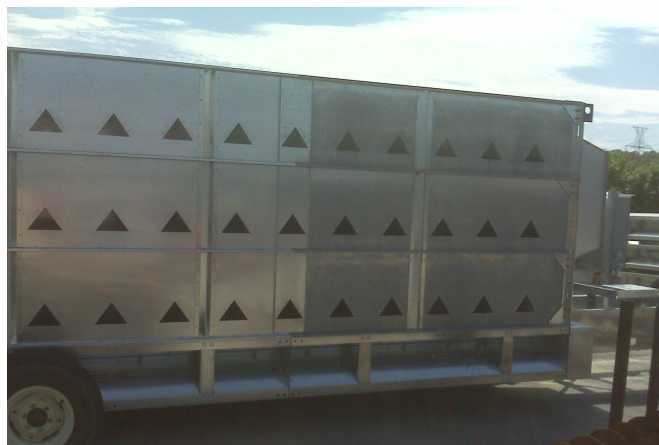
It has even been reported to occur on industrial products after being placed outdoors, as shown in the photo to the left. The material on the right side of the assembly darkened appreciably, compared to that on the left, during the first night outdoors. The galvanize use to make the bright area was mill passivated, while that used to for the dark area was oiled before shipping, *but not passivated*. The significance of outdoor storage is that it can allow dew to condense on the surface of the metal, the significance of which is explained below. Of course, as soon as the dew dries, corrosion ceases, usually leaving the observer wondering what happened in such a short time. Passivated

galvanize will resist such attack and allow the normal, colorless, slow-forming patina to develop. Such a patina can also form on unpassivated zinc if it is protected from aggressive corrosion when freshly exposed.

To prevent this problem from happening, unpassivated galvanize should not be applied to applications where the product will be placed outside. The surface of passivated galvanized sheet is 'deactivated' enough that atmospheric reactions are slowed to the point where its normal patina takes at least a few months to develop. Unpassivated zinc has a very active surface and experience has shown that corrosion products can form quickly and have different appearances. Allowing dew or other condensate to form on unpassivated sheet should be avoided.

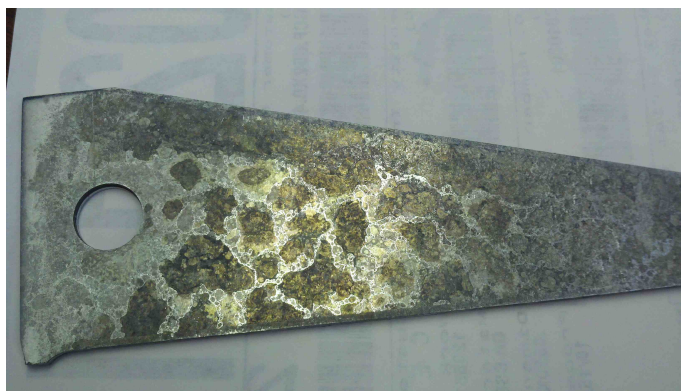
Another example of darkening is shown in the photo to the right. It is an automotive part that was out of specification for some other reason and was later noticed in an outdoor scrap bin. It triggered an inquiry because of concern that it was part of a shipment of defective zinc coating. All galvanized sheet used by the automotive industry is produced unpassivated for weldability and paintability reasons, so this piece was most likely affected by outdoor moisture that rapidly turned the surface partially black. As described above, this staining occurs very quickly by moisture that does not allow the normal oxidation of zinc in the zinc hydroxide, zinc oxide, zinc carbonate sequence that happens over longer periods.

It is most probable that it is a higher amount of sulfate ions that cause the black hue. *“The most important corrosive constituent in the atmosphere is sulfur dioxide, ...and sulfate ions come more from dew than other forms of precipitation.”*² *When heavy mists and dews occur in these atmospheres, they are contaminated with considerable amounts of acidic substances such as sulfur dioxide*³. Darkening is the result of forming these protective basic oxy-carbonate layers and is influenced by the presence of other atmospheric species, including sulfates and chlorides, which influence appearance (darkness). Rainwater is known to have a higher degree of mineralization, which could complex with sulfate ions, thus rendering it less aggressive

than dew condensate. Whatever the cause, darkening is a fast acting corrosion process that is very superficial, but creates an unattractive corrosion product. Of course, it is especially disconcerting when it occurs adjacent to bright galvanize.

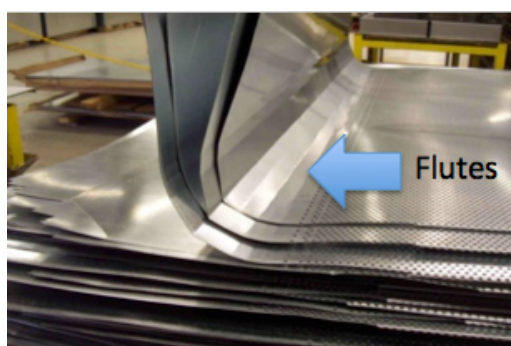
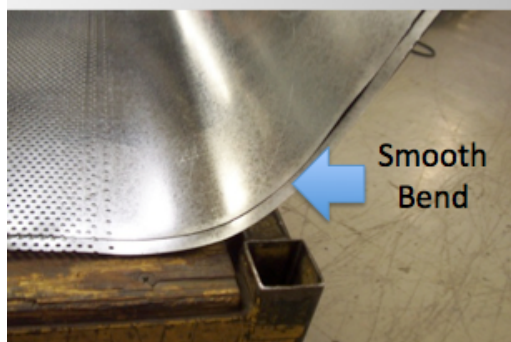
Fluting and stretching strains are marks that appear on the surface of the carbon steel sheet after forming operations. They are caused by discontinuous yielding of the steel substrate and show through the zinc coating. See page 3 of *GalvInfoNote 2.8* for more information on this phenomenon.

The photos to the left show sheets that were subjected to bending using a large radius. The bottom photo shows what is expected to occur when sheets are bent in a controlled manner – the curve is very smooth. When discontinuous yielding is present, the sheet will bend sharply every so often (flute) into a discontinuous curve that is totally unsatisfactory.

To prevent this, and as explained in *GalvInfoNote 2.8*, a small amount of cold work imparted to the sheet by temper rolling (or leveling) suppresses the discontinuous yielding phenomenon. With this behavior having been masked, the steel can be formed with no concern about stretcher strains or fluting.
